Subject: Report of [REDACTED] Photographic Laboratory Facilities supporting Detachment H.

The purpose of this report is to evaluate the effectiveness of the processing capabilities at this Detachment after eight months of operation.

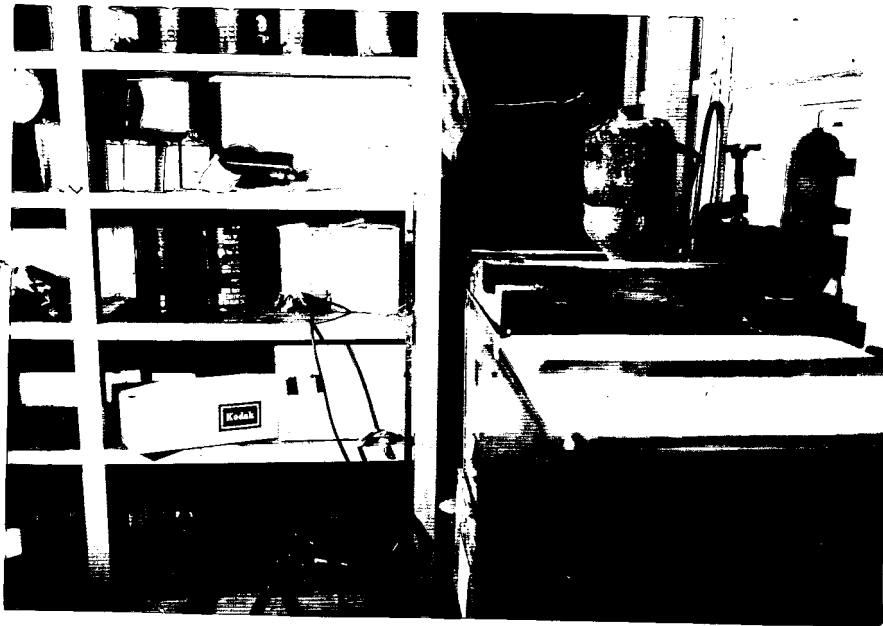
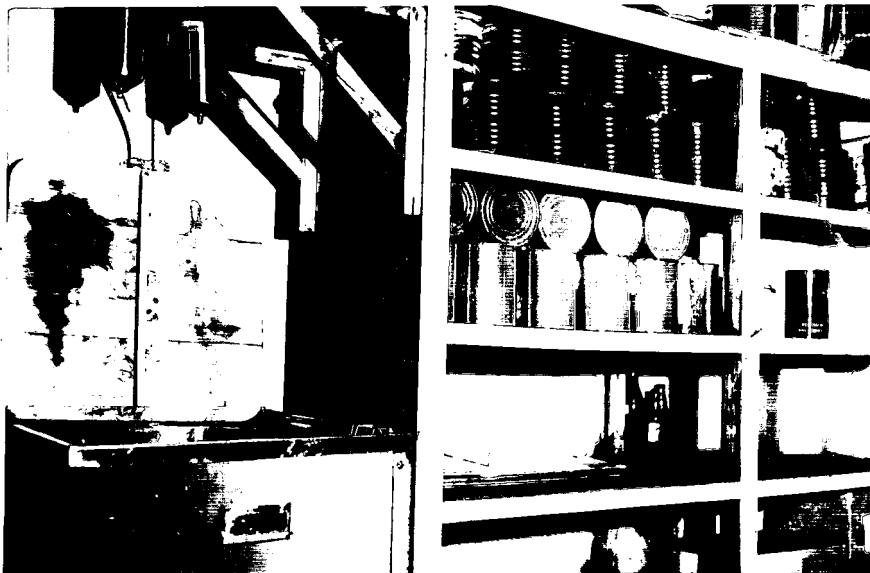
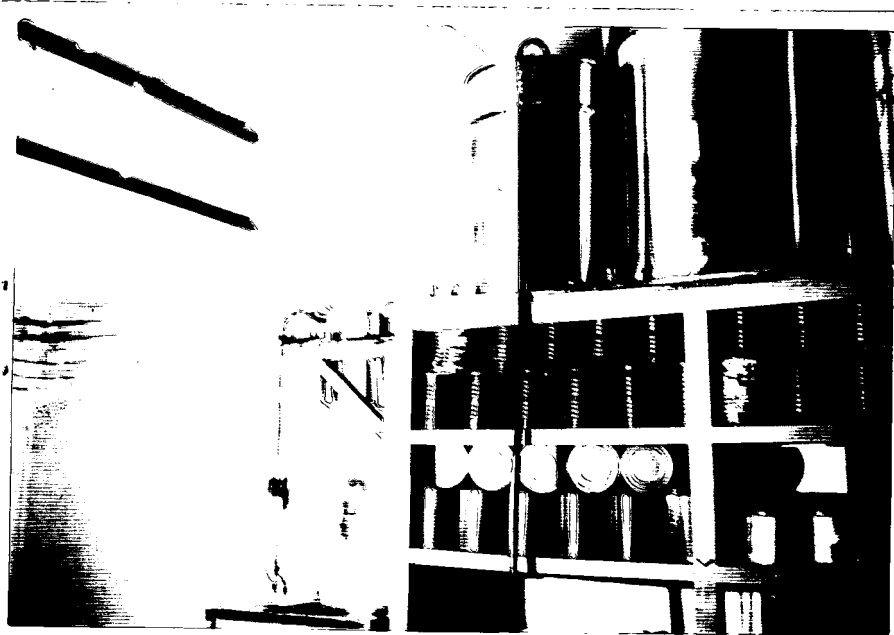
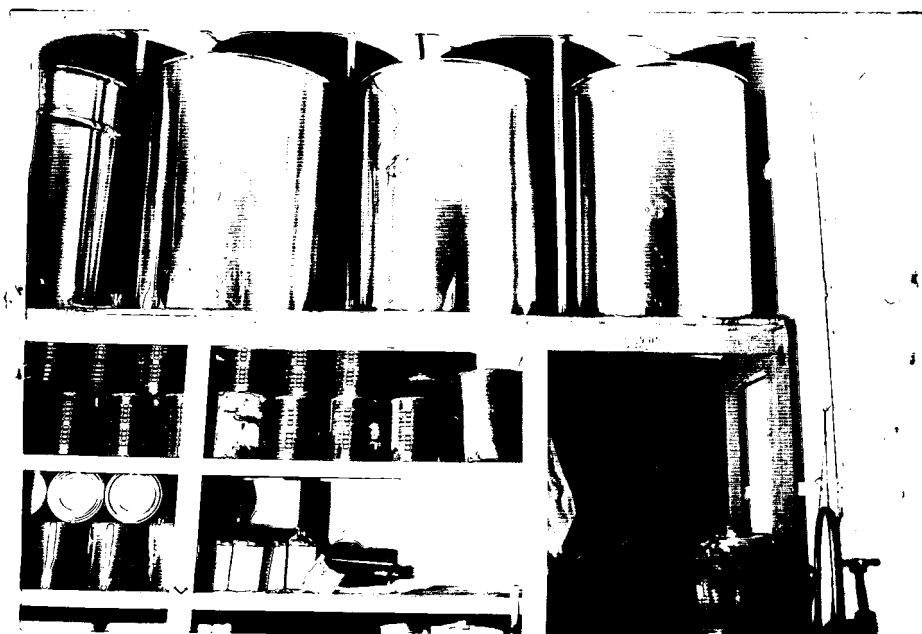
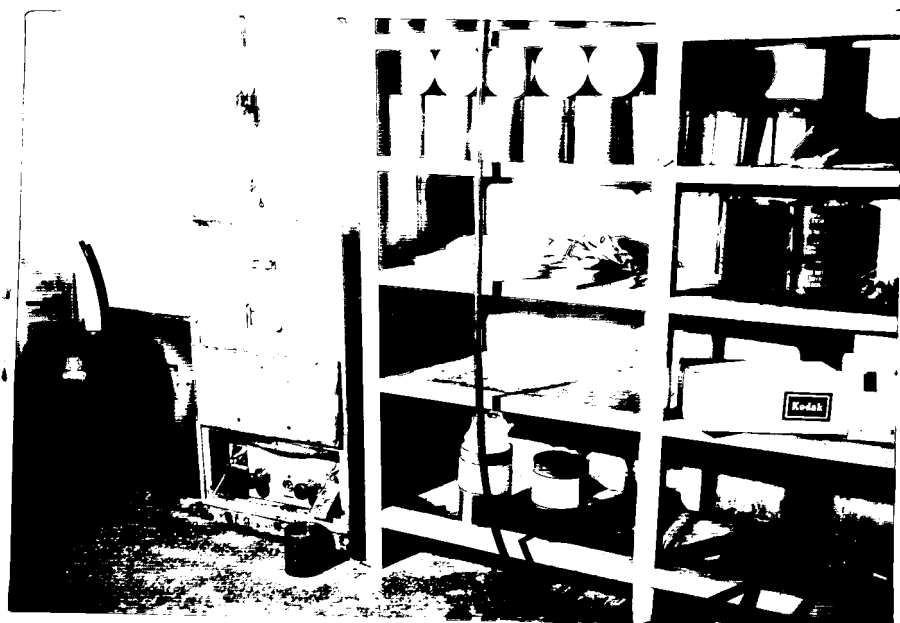
4. With an integrated chemical mixing and replenishment system, all of the processors could be utilized and greatly facilitate the processing of both types of film.
Note: Attached photo's.

1. The capability of the chemical mixing room is completely inadequate, particularly if sustained operation of processing both standard base film and thin base film is needed. It is recommended that the chemical mixing room be completely re-organized. The present room be enlarged and sufficient Dayton 100 Ltr. tanks and mix units be installed with pumps, filters, flow meters and valves so that these tanks can be switched to each machine. This will give complete flexibility to the system and maximum utilization of all processing machines. It is believed that the [REDACTED] will furnish additional building space and all labor for this installation. Ventilation fans should be installed for use when mixing chemicals to exhaust the chemical dust and various vapors. Floor drains be installed so that excess water from clean up and spilled chemicals can be drained. 25X1C
